# The Erie Installs Retarders in Marion Yard

Capacity of yard increased and operating cost reduced

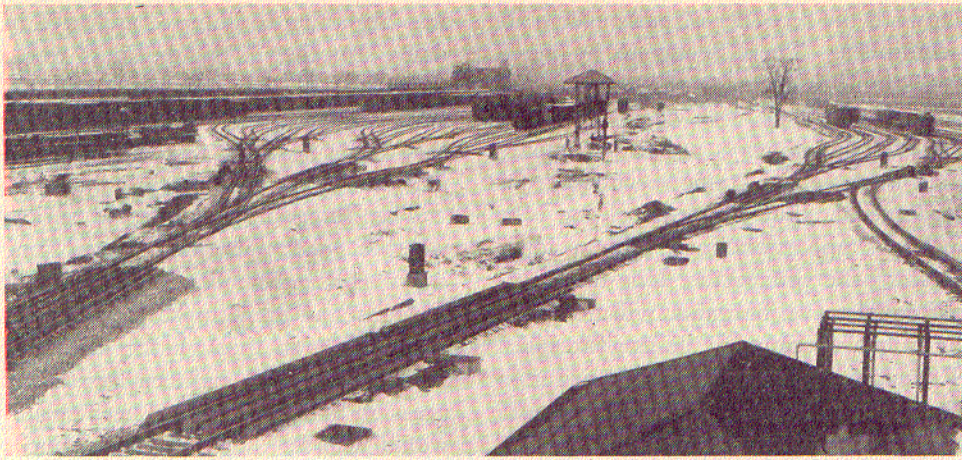
The Old Yard Is at the Left and the New at the Right

The old westbound yard included 16 tracks lying in a general east-and-west direction north of the main line. An l.c.l. freight transfer station was located just north of this old yard, and although it is planned to move these facilities elsewhere within the next few years, it was not necessary to do so in order to enlarge the yard, because the eight new tracks were located north of the l.c.l. transfer. Therefore, this arrangement leaves space for 12 additional tracks when the freight transfer is relocated.

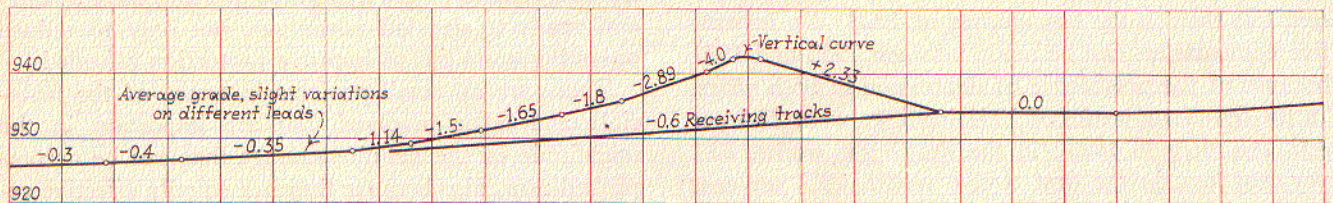
Plan of Yard Layout Showing Grades

- 17 Retarders
- 24 Switch machines
- 1 Track circuit for each switch

In designing the grades down the hump and throughout the yard tracks, consideration was given to the fact that many empty cars were to be classified. The climatic conditions and the fact that the prevailing wind is from the southwest also entered into consideration. As shown

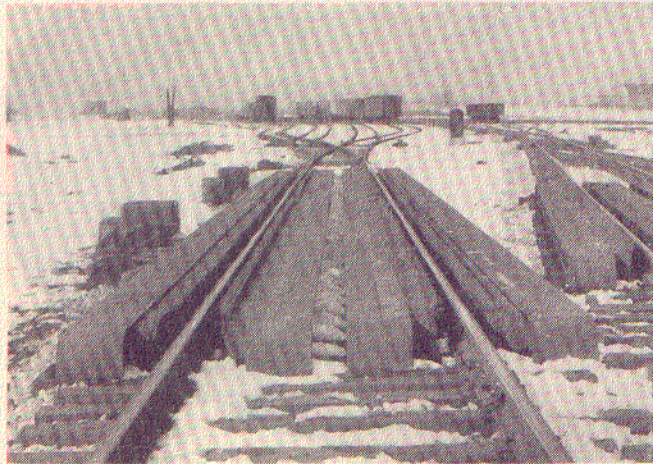
A Four-Track Group in the New Side of the Yard

The new arrangement necessitated that the hump be relocated near the center of the enlarged track layout. New leads were built from the new hump to connect with the 16 tracks in the old yard and the 8 tracks in the new addition. The capacity of the tracks varies from 39 to 125 cars, with a total yard capacity on the classification tracks of 2,000 cars. The natural slope of the ground in this area is westward, and a fill varying from 3 ft. to 13 ft. required approximately 76,000 cu. yd. of clay, with a top dressing of cinders. New 110-lb. rail with treated ties and crushed rock-ballast were used down the hump and throughout the retarders and switches, while 100-lb. relay rail with gravel ballast were used on the yard tracks.
